Manhole Inspection Summary

Manhole # S33AA_018MH

Insp Date: **10/15/07 12:47 PM**

Location Address: **M&T BANK N HOWARD ST** Cross Street: **W MADISON ST**

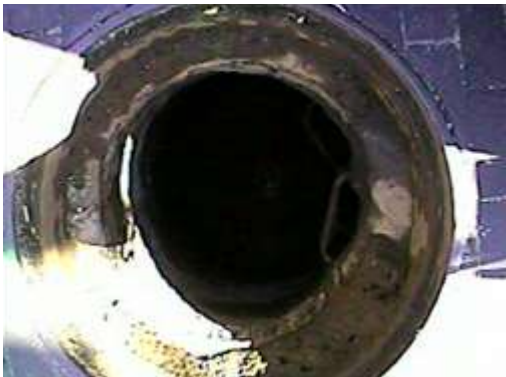
Defect 1

Condition: ☐ Sound ☐ Cracked ☐ Root Intrusion ☒ **Loose Brick** ☐ Deteriorated

Loose bricks in frame adjustment

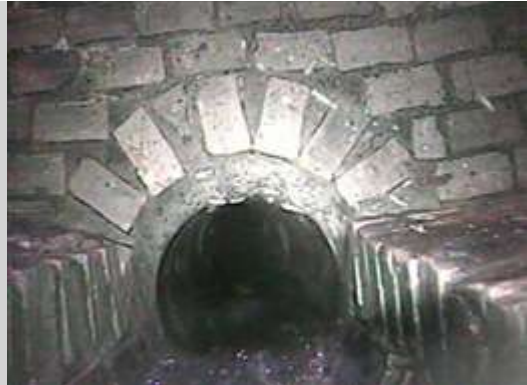
12 O'Clock Outflow

10 in. Circular Gravity Sewer
Pipe Out @ 12 O'Clock

Loose bricks in frame adjustment

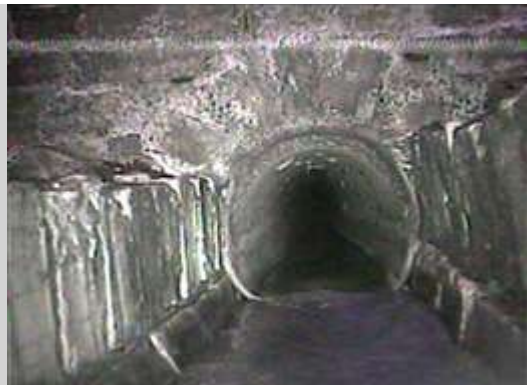
6 O'Clock Inflow

10 in. Circular Gravity Sewer
Pipe In @ 6 O'Clock

Loose bricks in frame adjustment

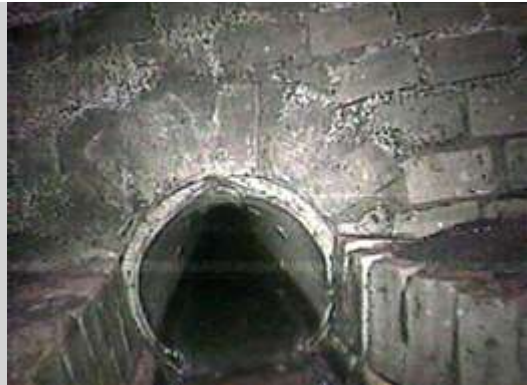
9 O'Clock Inflow

8 in. Circular Gravity Sewer

Pipe In @ 9 O'Clock

Loose bricks in frame adjustment
